# Waveguide Inspection Techniques

J. R. Loreman

R. F. Systems Development Section

*Because of the demonstrated contribution of certain waveguide internal flaws to system noise and high transmitter back power, an improved inspection is being performed on S-band waveguide using a new precision borescope.*

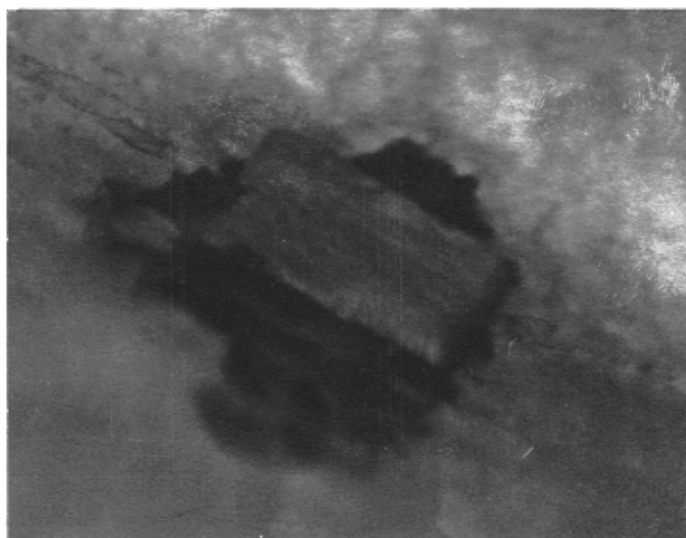
Approximately 20 meters of S-band copper waveguide stock has been inspected prior to being used for the fabrication of water-cooled S-band high-power waveguide assemblies. The waveguide stock was cleaned by a nonetching chemical process in order to eliminate dirt and allow close inspection of the internal surface. Two categories of mechanical flaws which have caused waveguide arcing in the past were detected. These mechanical flaws are the swaging of loose metal into the internal wall of the waveguide during the extrusion process (Fig. 4) and voids or spaces which break through the internal waveguide surface. In addition, surface ripples and various deposits and chemical discolorizations were detected. These additional defects have not been identified with respect to the failure of waveguide components. The inspection has prevented defective portions of the wave-

**Fig. 4. Mechanical flaw (swaging of loose material  
into internal surface)**

be inspected with the borescope. Waveguide stock containing flaws will be eliminated or identified to prevent these flaws being included in finished high-power S-band waveguide assemblies. In addition, a program of evaluation will be carried out to identify all types of internal variations with respect to waveguide component performance.
